Jim Baird Inspection Services

Inspection Report

- For : Dwelling at 640 Every St., Local, GA zipzip
- For : Joe Somebody
- Site Visit Performed: December 05,, 2025.

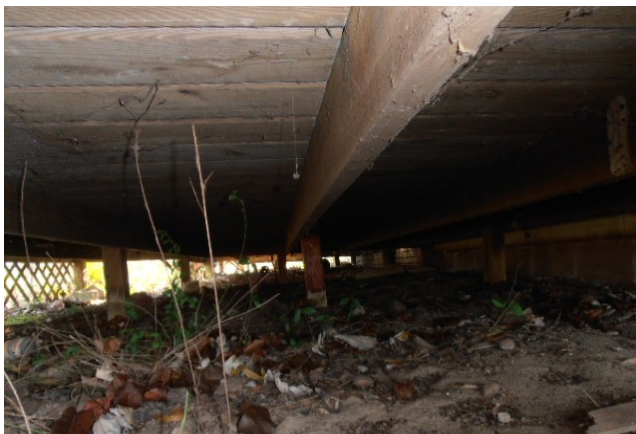
Under main house the beams are slightly overspanned. Under north addition joists are overspanned, and under enclosed deck area and existing outside deck they are way overspanned.

Overspanned Deck Joists

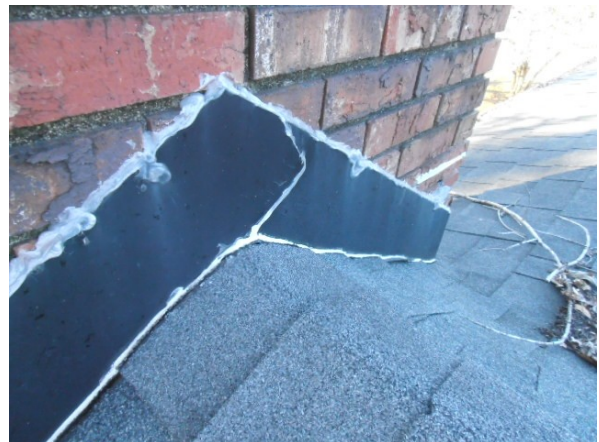
- 4.1.1) "Architectural" two-ply asphalt shingles cover all roof areas. They look fairly new.
